## TEST REPORT

<b>Laboratory</b>	ROOF AND FAÇADE ELEMENTS (CAR)	<b>O/References</b>	DE 651XN877 CAR 17016-3 Page 1/6
-------------------	--------------------------------	---------------------	--

## 1. DESCRIPTION OF THE SAMPLE

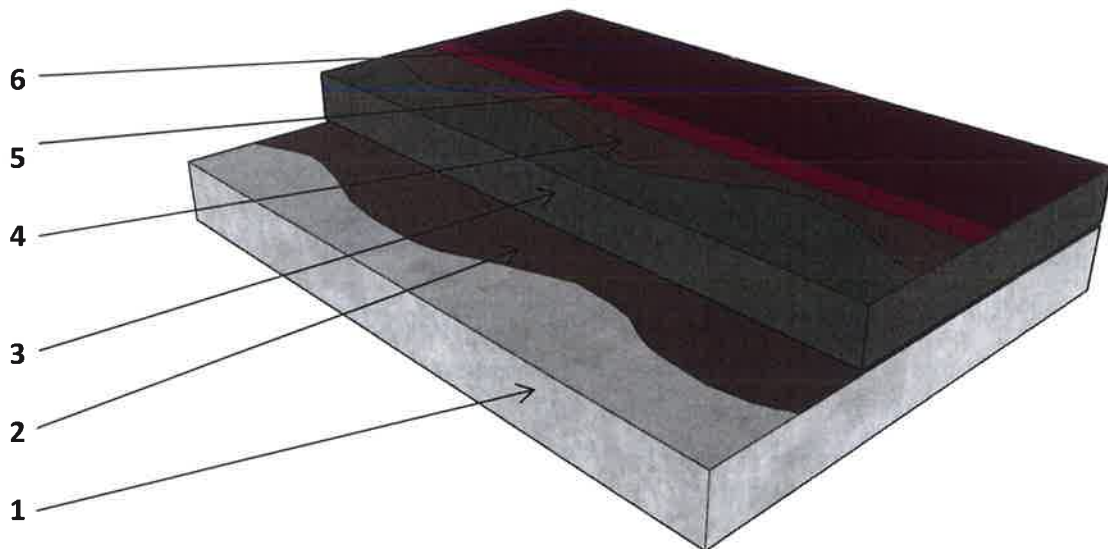
Figure 1

1	<b>Substrate</b>	Concrete type "C30/37 S3 14 EE2"; thickness 150 mm; coated with a primer "PC® EM PRIMER (SOPRADERE QUICK PRIMER)"; consumption >0,2 l/m <sup>2</sup> ; 4 holes with diameter 50 mm are drilled through the concrete substrate.
2	<b>Fastening of the insulation</b>	Glued with hot bitumen type "110/30" (Soprema) under the panels ( $\pm 5$ kg/m <sup>2</sup> ), between the panels and on top of them ( $\pm 2$ kg/m <sup>2</sup> ).
3	<b>Insulation</b>	Cellular glass panels "FOAMGLAS® T3+" ; thickness 100 mm ; dimensions of the panels 600 mm x 450 mm.
4	<b>Fastening of the waterproofing 1<sup>st</sup> layer</b>	Fully torched on the top coat of hot bitumen.
5	<b>Waterproofing 1<sup>st</sup> layer</b>	Bituminous waterproofing membrane Bituminous waterproofing membrane "SOPRAROCK® PB P3"; thickness 3 mm.
6	<b>Waterproofing 2<sup>nd</sup> layer</b>	Bituminous waterproofing membrane "SOPRALENE® OPTIMA 4 C3"; thickness 4 mm; fully torched on the 1 <sup>st</sup> layer.

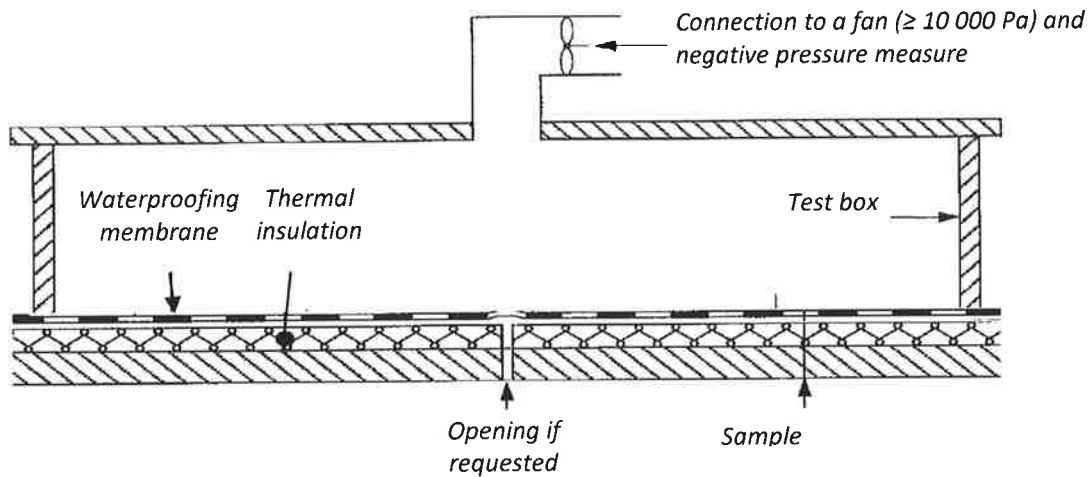
Figure 2 : Vertical cross-section of the test box

The negative pressure cycles are applied under the test box with a fan and an electronically controlled valve system allowing the creation of cycles. A storm is a sequential combination of negative pressure cycles. One applies the depressions indicated in figure 3. The test continues until the breaking of the sample per steps of 500 Pa (adhered systems) or 100 N/fastener (mechanically fastened systems) for  $Q_{100\%}$ .

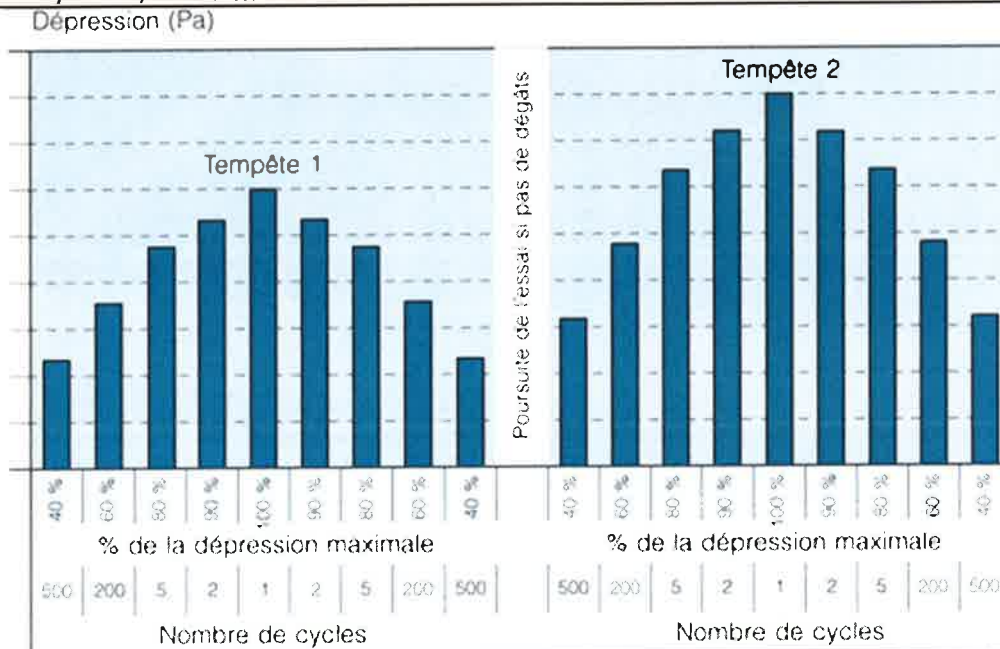
Figure 3 : Sequential combination of negative pressure cycles during a storm

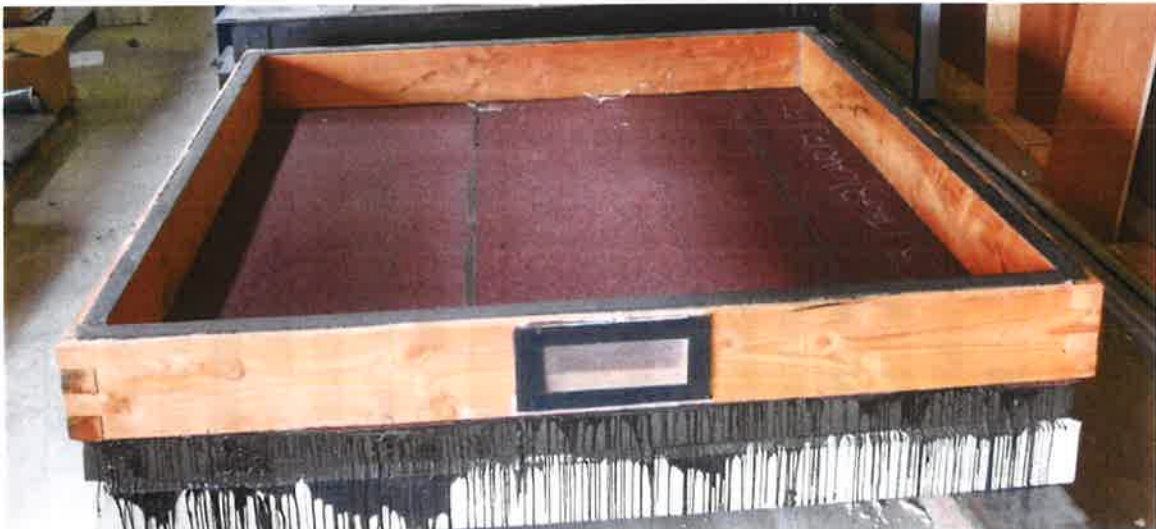
Picture 1 – Sample after the test (no break).

**The test has determined  $Q_1 = 10000$  Pa**

Break – type	No break
--------------	----------

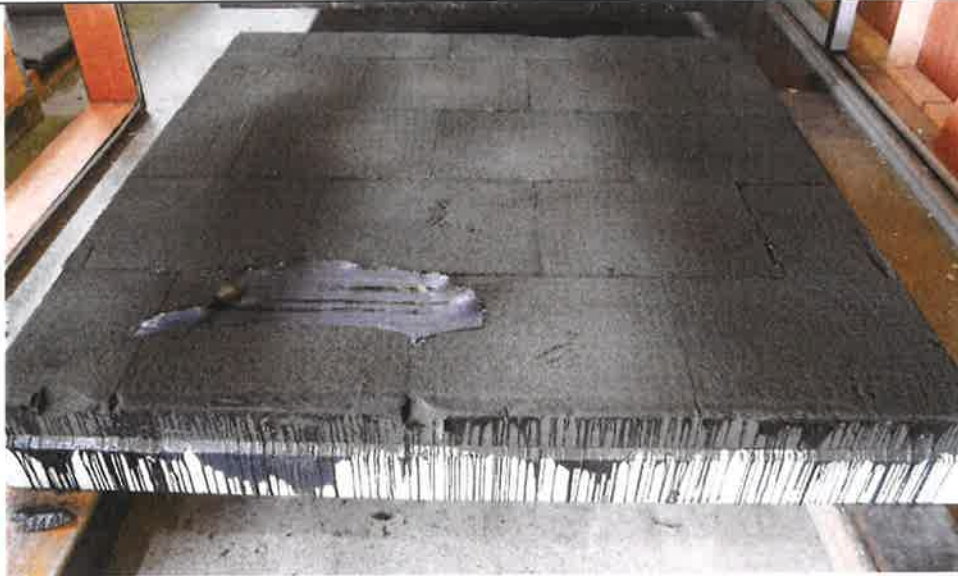
Picture 2 – Sample after the test during disassembly.

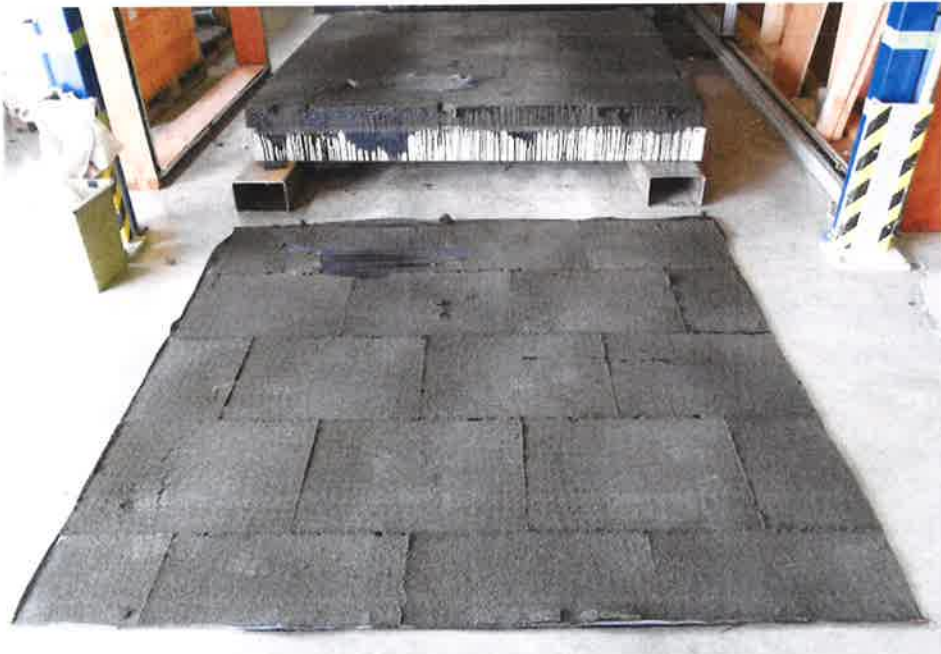
Picture 3 – Sample after the test during disassembly.

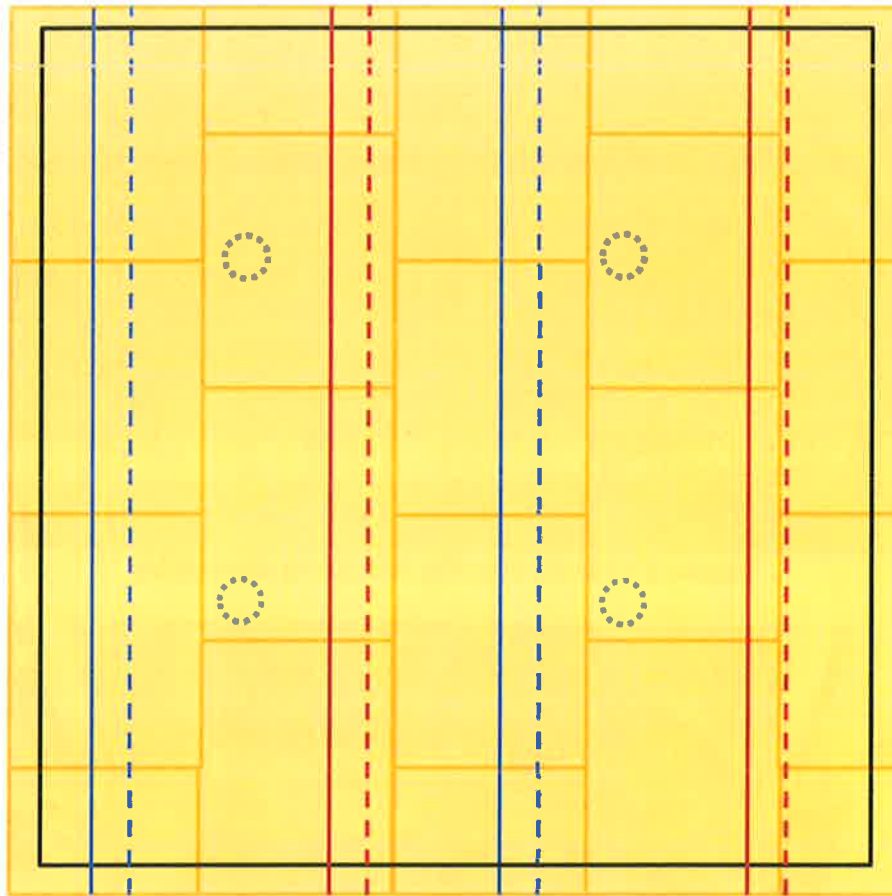
Joints between insulation panels
-

Joints of the waterproofing 1<sup>st</sup> layer
-

Joints of the waterproofing 2<sup>nd</sup> layer
-

Hole drilled in the concrete substrate
-

Test box frame

**Figure 4** - disposition of the components of the sample  
(indicative scheme made by the laboratory during disassembly)

The disposition of the components of the sample is given in figure 4
